Manhole Inspection Summary

Manhole # S45UU_002MH

Record Plat: **45UU** Node: **002** Status: **Found**

Location Address: **2910 HILLEN RD**

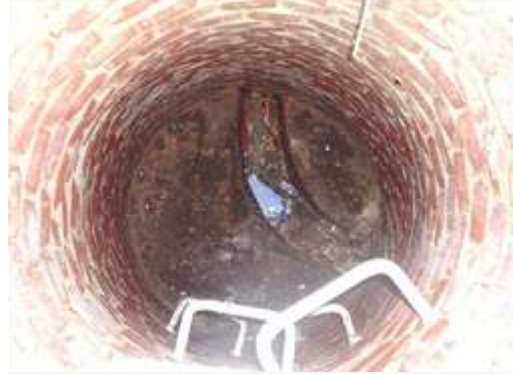
Top View

Infiltration: ☐ None ☐ Joint ☐ Cracks ☐ Mortar ☐ Roots ☒ **Wall**

Surcharge ☒ **Evidence Of Surcharge** Depth: **1** (ft.) ☐ Active Surcharge Present

Barrel infiltration. Evidence of surcharge - Bench debris. Channel debris.

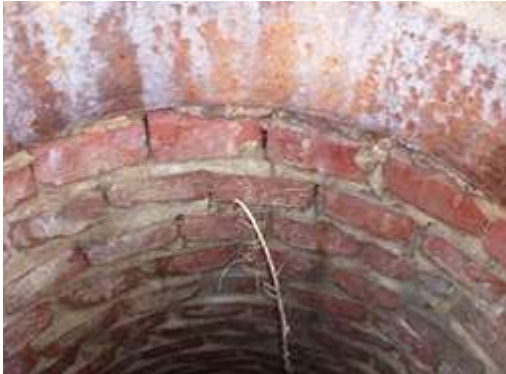
Defect

Condition: ☐ Sound ☐ Cracked ☒ **Root Intrusion** ☐ Loose Brick ☒ **Deteriorated**

Infiltration: ☐ None ☒ **Joint** ☐ Cracks ☐ Mortar ☒ **Roots** ☒ **Wall**

Corbel deterioration, root intrusion and infiltration.

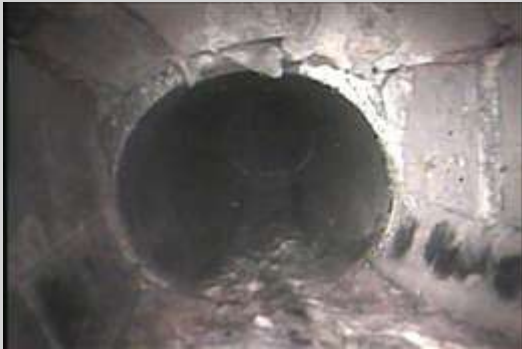
8 in. Circular Gravity Sewer Pipe Out @ 12 O'Clock

Infiltration: **Evidence** Pipe Seal Cond: **Unknown**

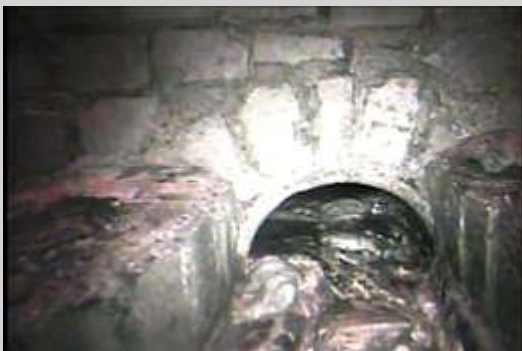
8 in. Circular Gravity Sewer Pipe In @ 3 O'Clock

Deposits: ☐ None ☒ **Mud** ☐ Sludge ☒ **Debris** ☒ **Grease**

Silt Depth: **3** (in.) Deposits Extent: **Medium**
